A-ALERT HOME INSPECTIONS

THIS IS A SAMPLE REPORT NOT A FULL REPORT

Nice Ave.
Somewhere, NJ

Inspection Date: 6/3/2009
Inspection Time: 9:00:00 AM

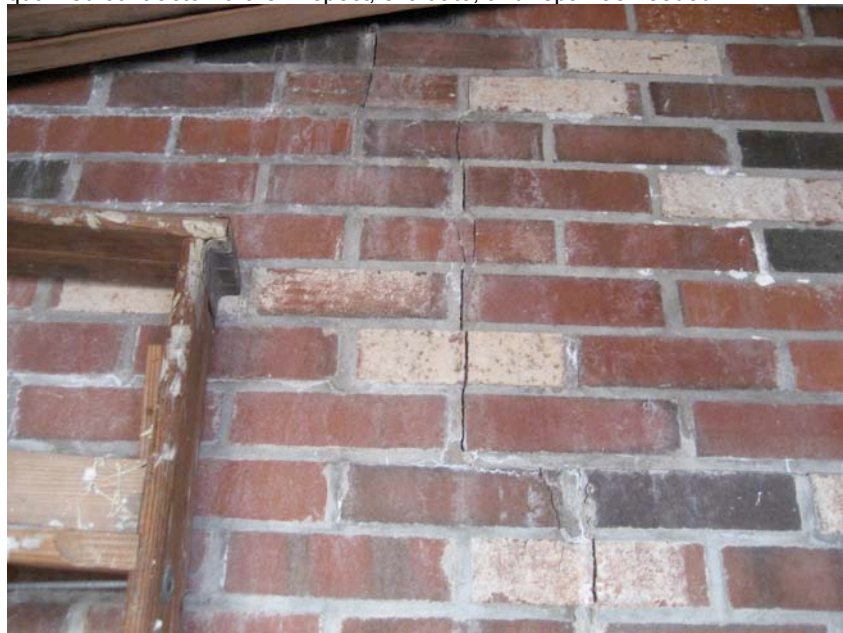
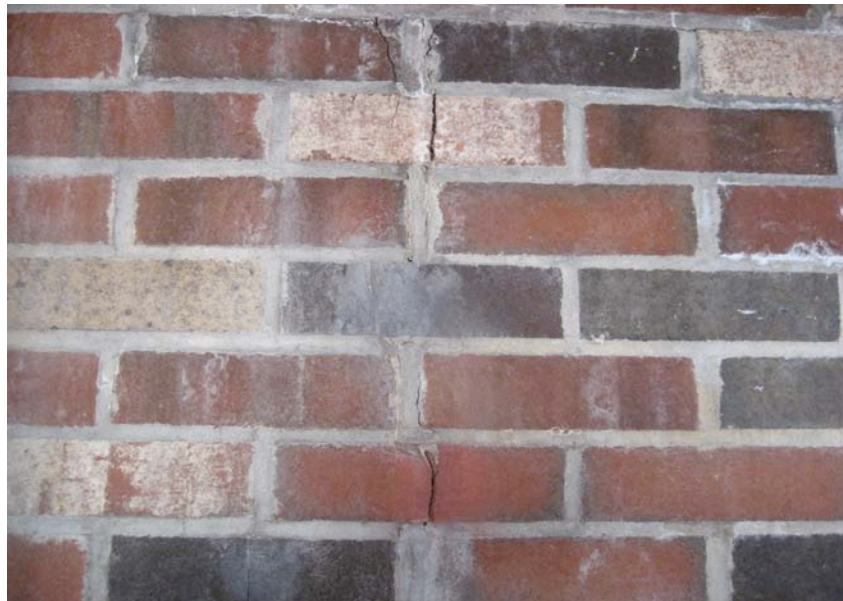
Location: In the front of the home.

Brick
Cracks (major) --- Some cracks noted are more than what would normally be expected. This may indicate a structural problem. We recommend to have a qualified contractor further inspect, evaluate, and repair as needed.

Rating: **Discussed** --- This was discussed at the inspection with the inspector.
Maintenance Required

Condition: Cracks (major) - Some cracks noted are more than what would normally be expected. This may indicate a structural problem. We recommend to have a qualified contractor further inspect, evaluate, and repair as needed.

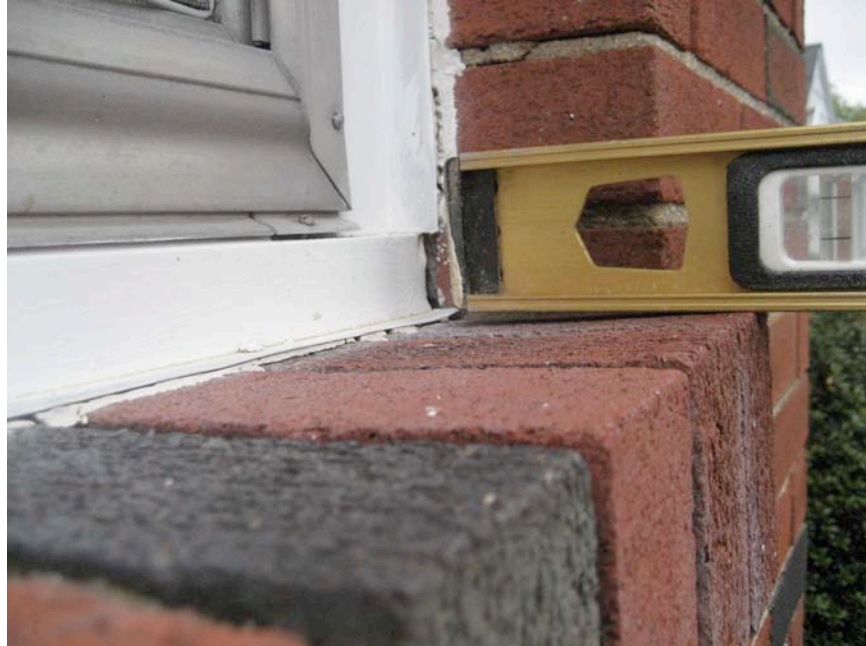
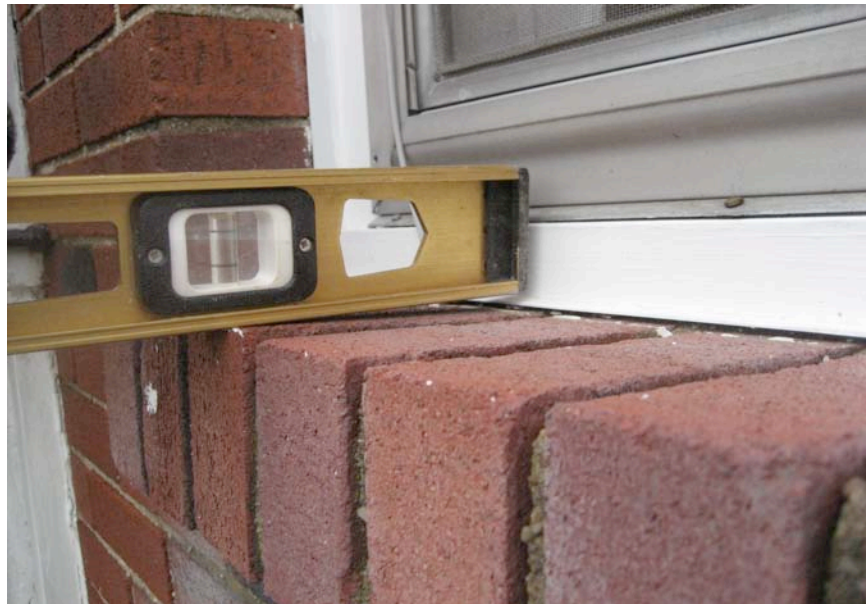
Water trap --- There is a water trap [An area that will hold, cause water to enter, or flow toward the home.] Recommend to correct this condition to keep water flowing away from the home.

Comments: Location: At the base of two windows right front of the home.
This condition may be allowing water to enter behind the brick. There may be hidden damage. We recommend to have a qualified contractor evaluate and correct this condition.

Rating: Maintenance Required

Condition: Water trap - There is a water trap [An area that will hold, cause water to enter, or flow toward the home.]

Comments: This condition may be allowing water to enter behind the brick. There may be hidden damage. We recommend to have a qualified contractor evaluate and correct this condition.

Recommend to correct this condition to keep water flowing away from the home. Location: At the base of two windows right front of the home.

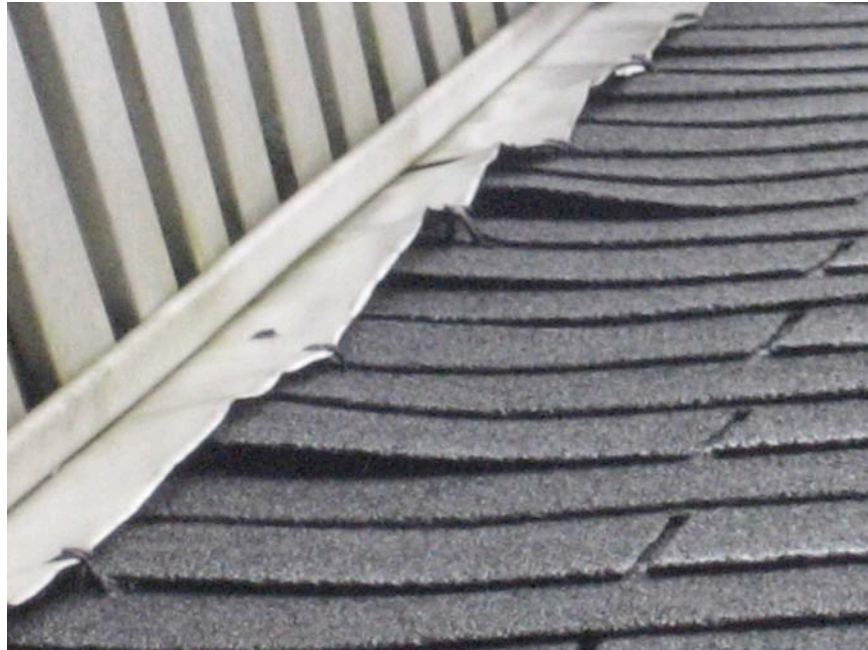
Location: In front of the home
Maintenance Required

Open flashing --- Flashing appears to be open. Be sure to check and repair to help prevent leaks.

Comments: Improper Instillation was noted. Have this condition repaired by a professional.

Condition: Open flashing - Flashing appears to be open. Be sure to check and repair to help prevent leaks.

Comments: Improper installation was noted.

Have this condition repaired by a professional

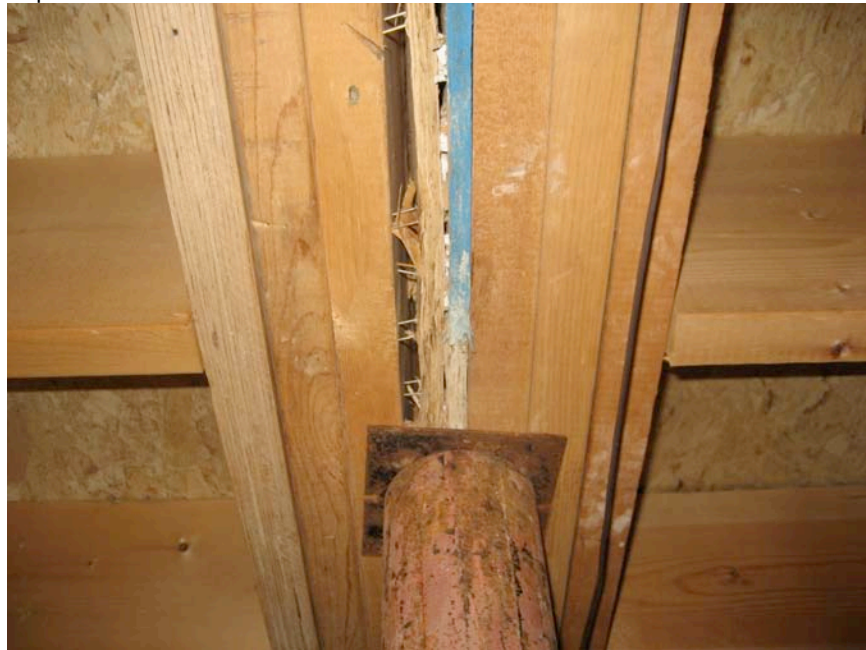
Location: The left side in the basement.

Joist: Solid Wood
Rating: Acceptable
Beam:
Condition: **Poor bearing** --- Poor bearing surface was noted . This can cause framing to slip off the bearing surface resulting in damage to the structure. Repair is required.

Condition: Poor bearing - Poor bearing surface was noted. This can cause framing to slip off the bearing surface resulting in damage to the structure. Repair is required.

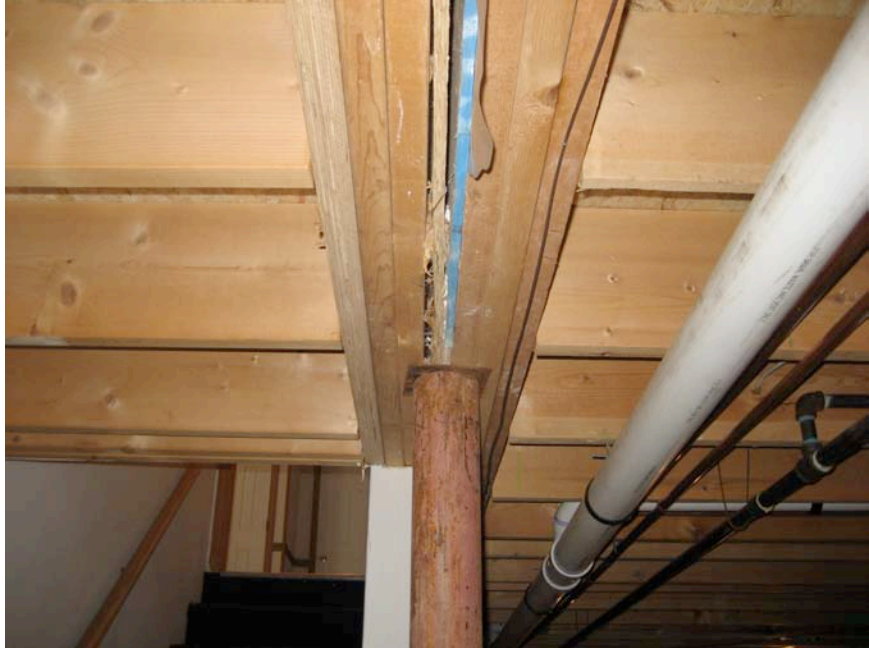
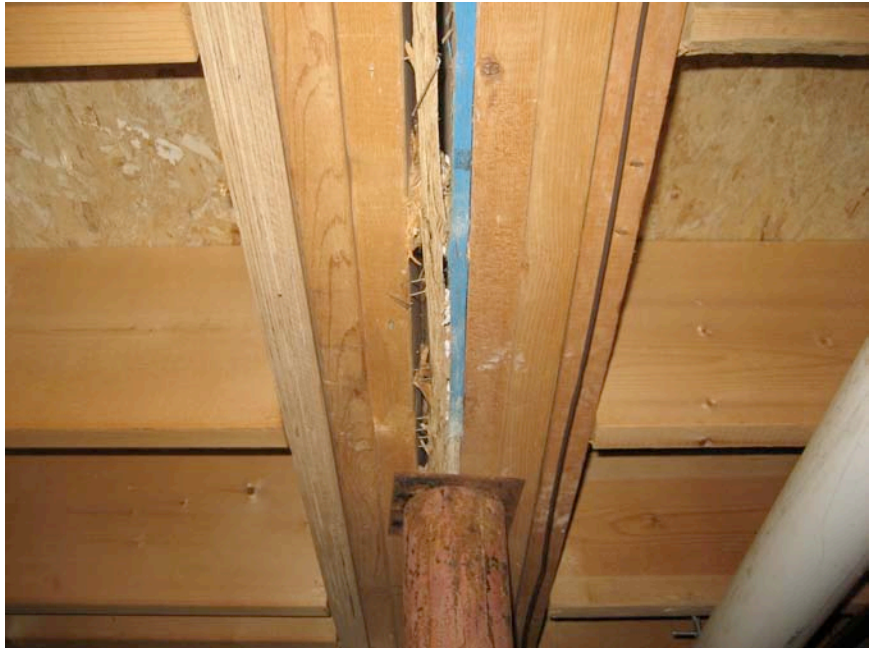
Location: The left side in the basement.

Displacement --- Displacement was observed. This is do to erratic movement. The cause of misalignment should be investigated because it can be a sign of settling or sagging of the structure.

Contractor evaluate --- This condition can sometimes indicate a structural problem. Recommend a contractor to evaluate and repair as needed.
Maintenance Required

Condition: Displacement - Displacement was observed. This is due to erratic movement. The cause of misalignment should be investigated because it can be a sign of settling or sagging of the structure.

Condition: Contractor evaluate - This condition can sometimes indicate a structural problem. Recommend a contractor to evaluate and repair as needed.

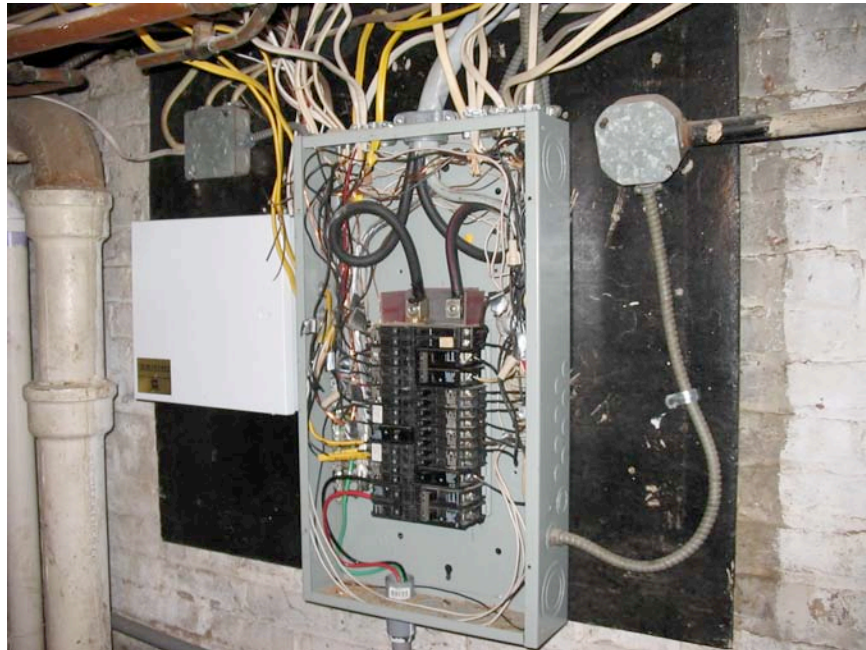
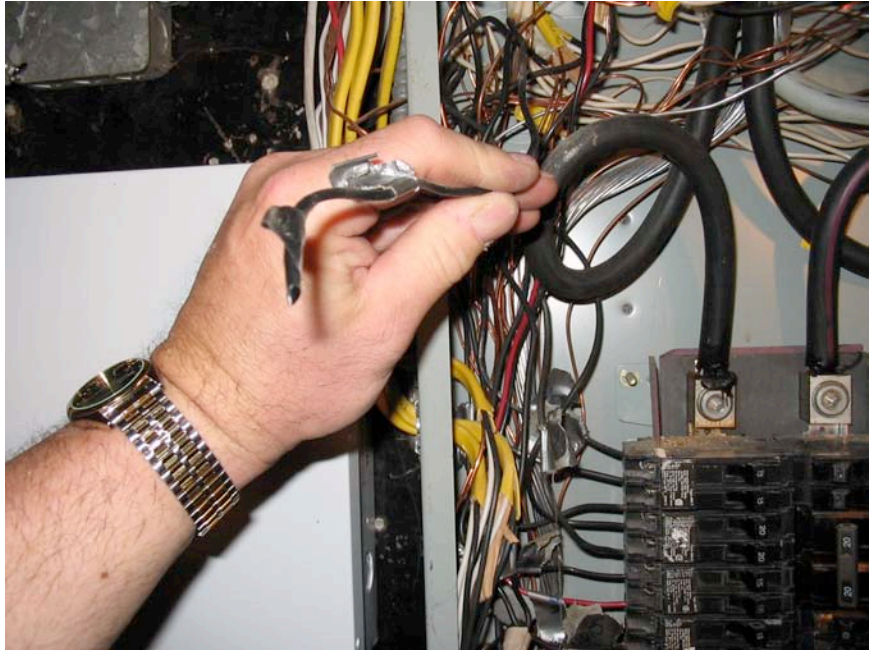
Main Panel

Condition: **Abandoned wiring ---** The inspector observed abandoned wiring. It is recommended that this wiring be removed by a qualified person..

Rating: Hazardous
Location: Basement
Amp Rating: 150
Volts: 120/240

Condition: Abandoned wiring - The inspector observed abandoned wiring. It is recommended that this wiring be removed by a qualified person..

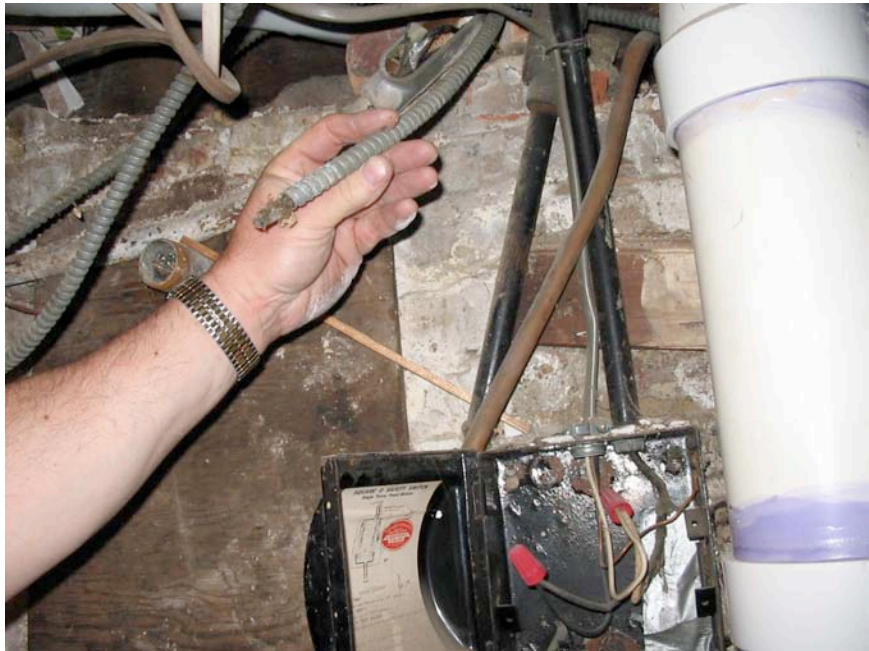
Sub Panel

Discussed --- This was discussed at the inspection with the inspector.

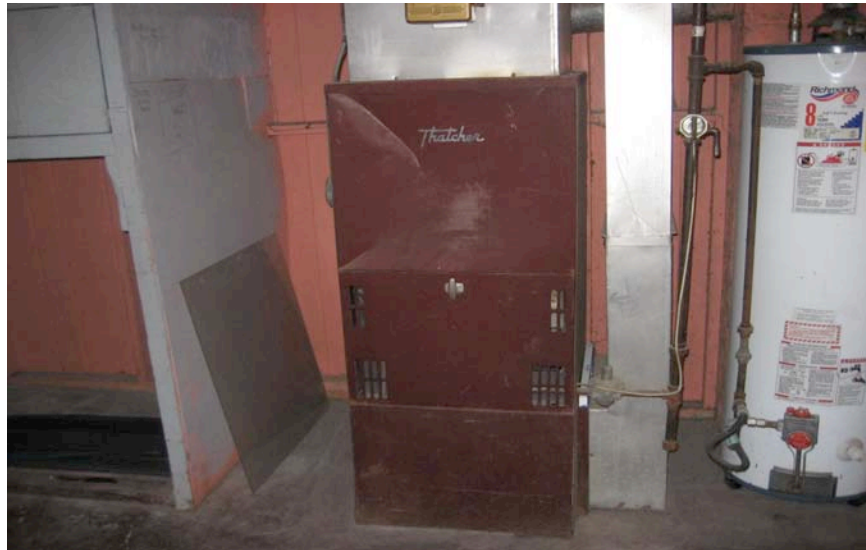
Condition: **Dirty [heat unit]** --- The inspector feels that the heating equipment and or its components are dirty. Recommend to have a qualified person clean and service before closing.

Condition: Dirty [heat unit] - The inspector feels that the heating equipment and or its components are dirty. Recommend to have a qualified person clean and service before closing.

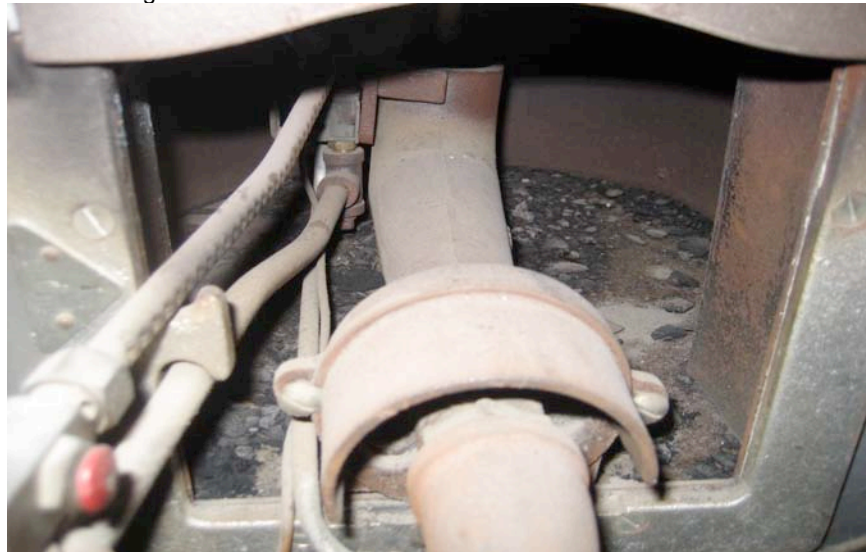
Discussed --- This was discussed at the inspection with the inspector.
Rust/scaling heat exchange --- The inspector noted rust located at the bottom of the heating unit. The rust and or scaling may be from the heat exchange. We recommend to have the unit cleaned, inspected and serviced before the closing.

Condition: Rust/scaling heat exchange - The inspector noted rust located at the

bottom of the heating unit. The rust and or scaling may be from the heat exchange. We recommend to have the unit cleaned, inspected and serviced before the closing.
Condition: Budget to replace -- Heat unit -
In the inspectors opinion, the heating unit appears to be nearing the end of its life expectancy. Budget to replace.
Maintenance Required

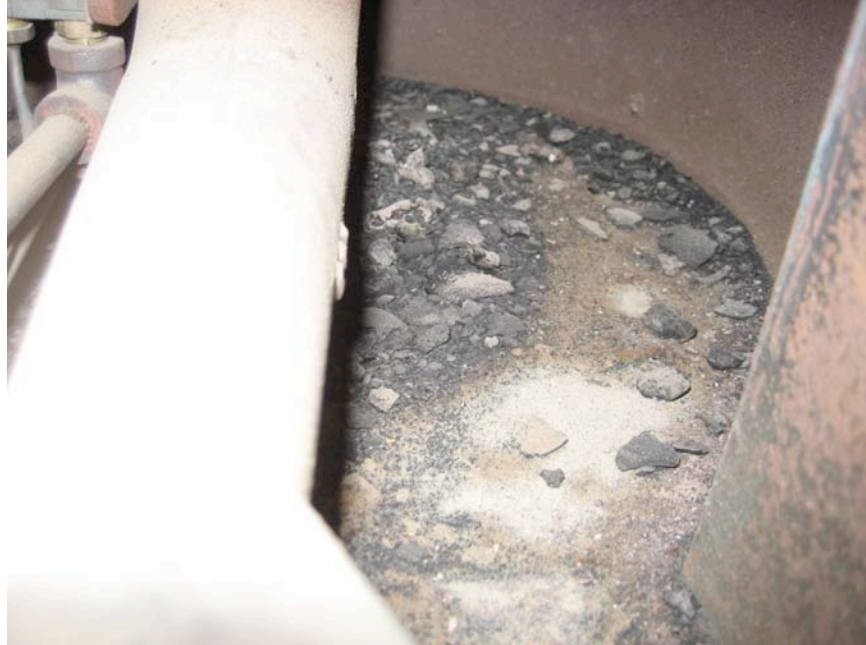
Budget to replace -- Heat unit --- In the inspectors opinion, the heating unit appears to be nearing the end of its life expectancy. Budget to replace.
Maintenance Required

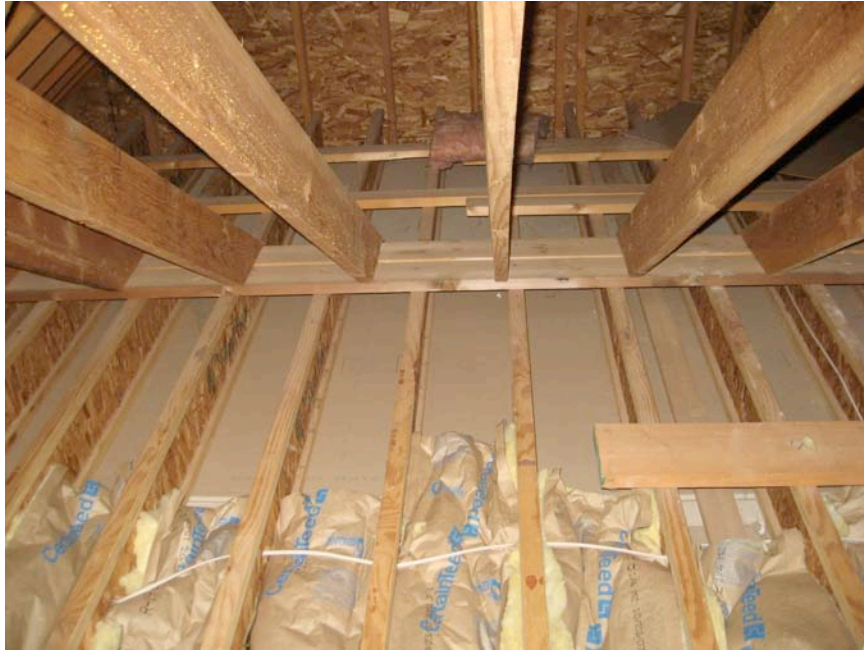
Rating: Location: Right side of the attic.
Maintenance Required

Condition: **Missing insulation** --- Insulation is missing. Recommend missing insulation be installed to lower heat loss.

Condition: Missing insulation - Insulation is missing. Recommend missing insulation be installed to lower heat loss.
